PROJECT SHEET

**Villa Canali Gaslini
(Restoration of Decorative Elements)**

GENOA, ITALY

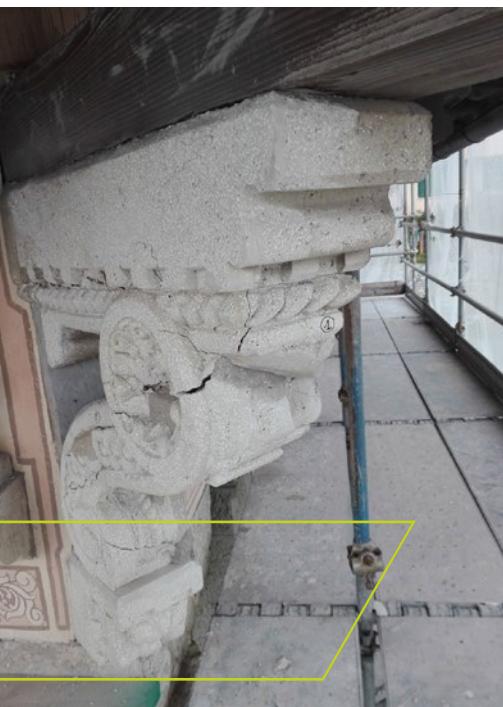
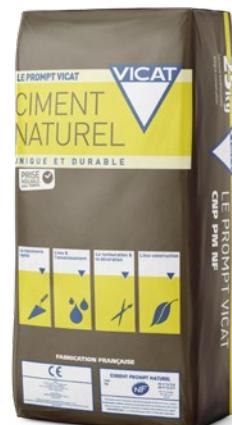
Aligned with the large consoles and the decorative cement columns, water infiltration caused the oxidation of the iron reinforcements, resulting in expansion. The internal stresses generated by this expansion created cracks and, in some areas, led to the detachment of parts of the decorative elements.

The most deteriorated elements were restored through an initial operation involving the dismantling and cataloging of

the damaged parts. All iron reinforcements were then treated with a passivating agent, and the detached parts were repositioned, filling remaining cracks with a mortar based on natural PROMPT cement and color-matched sand to blend with the original conglomerate.

The large consoles of the central section were particularly damaged. Their material had lost cohesion, so it was decided to remove the hazardous parts and rebuild them using a mortar based on natural PROMPT cement. For this operation, joints were covered with a base color

matching the granular support to ensure visual unity. A potassium silicate stain was then applied.
