PROJECT SHEET

Restoration of Palazzo Castiglioni Façade

MILAN, ITALY

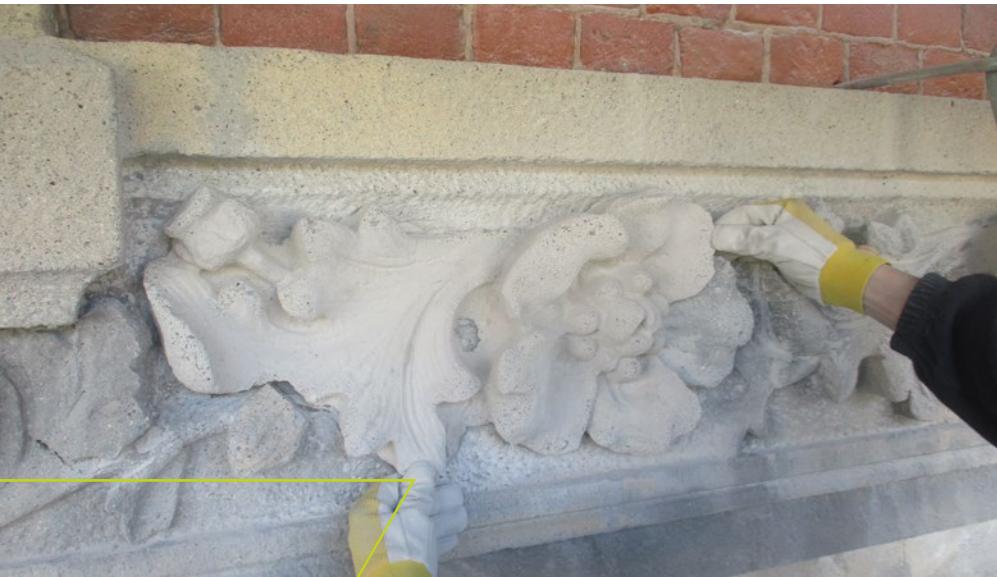
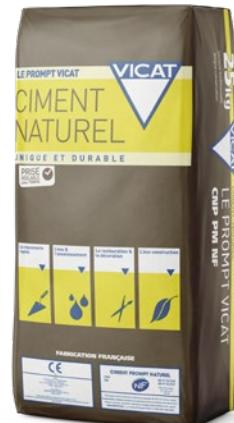
The ornate decorative elements, inspired by naturalistic motifs and made from a mix of cement binder and heterogeneous aggregates, both carbonate and silicate-based, were severely deteriorated. Some parts were detached or missing due to water infiltration, which had corroded the iron reinforcements and lintels, causing fractures and cracks in the mortar and creating a risk of falling.

After mapping the deterioration, restorers carefully removed and cataloged detached fragments of the decorative reliefs, mainly concentrated in the floral cornice above the large window on the

Palazzo Bovara side. The cement and brick façade was cleaned using biocidal treatment, manual washing with aqueous surfactant solutions, and controlled mechanical cleaning with 120-mesh garnet or calcium carbonate to remove hardened deposits and thick black crusts. Cleaning methods were adapted case by case to best preserve the original surfaces and the ochre finish, which remained well preserved in some areas.

Exposed iron reinforcements were then passivated, cracks consolidated with controlled injections of fluid mortar based on natural hydraulic lime or epoxy resin, and gaps filled with a mix of natural Prompt cement, hydraulic lime, and aggregates of varying sizes.

Missing parts of the cornice were restored by repositioning salvaged fragments and recreating lost sections with natural Prompt cement, using silicone molds of the original based on the repeatable decorative modules. Repositioning was carried out with precision using adhesive and pinning, carefully sealing connection points to prevent water and moisture ingress.

The decorative ochre finish, including the pink marcapiano band, was applied with lime-based pigments in glazes; lime colors were consolidated by applying lime nanoparticles in ethanol (5 g/L). The brick façade was protected with polysiloxane.

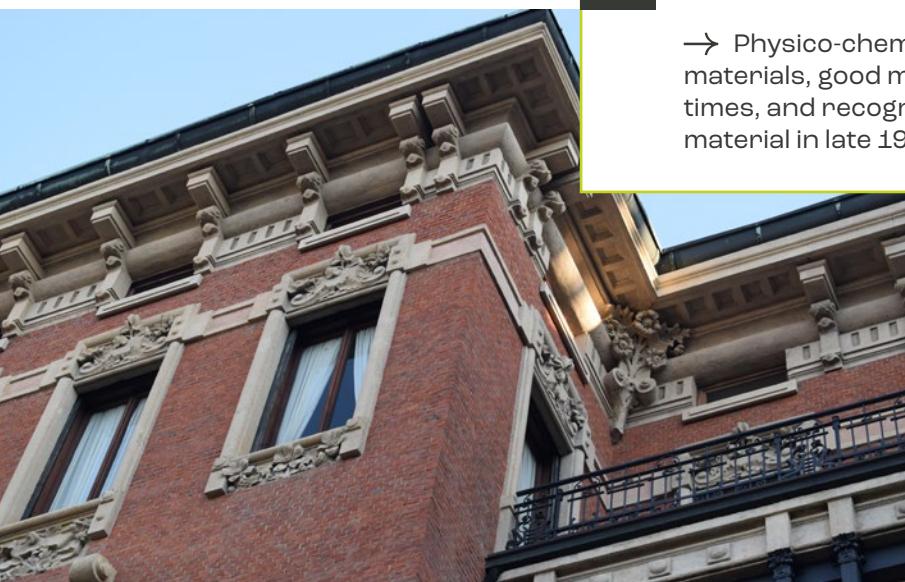
Reconstruction of decorative elements using silicone molds, filling of cracks, and restoration of degraded areas of the decorative cement.
