**PROJECT SHEET**  
**Oyster Basin Renovation**

ÎLE D'OLÉRON, FRANCE

Repair of an oyster depuration basin for an oyster farmer on Île d'Oléron. The work required a product resistant to

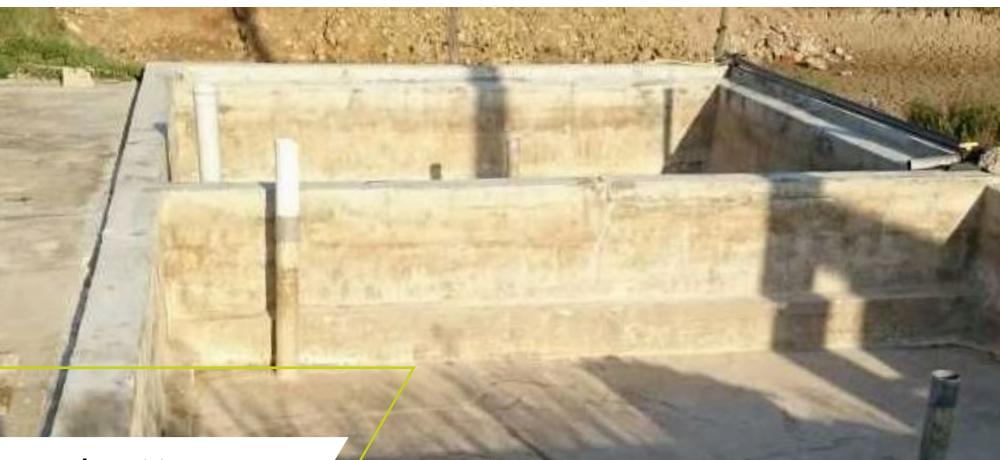
Avant travaux

marine conditions, capable of sealing leaks, repairing cracks, and applying a waterproofing and finishing coat.

- Repair and filling of cracks
- Sealing leaks through the structure
- Waterproofing joints between wall and base

- Binder: 600 kg/m<sup>3</sup> CNP
- Mix: 1 part sand (0/4) + 1 part CNP
