**PROJECT SHEET**  
**Concrete Pipe Repair**

ISÈRE, FRANCE

Repair of a concrete pipe dating from the 1850s, supplying basins and fountains on a private

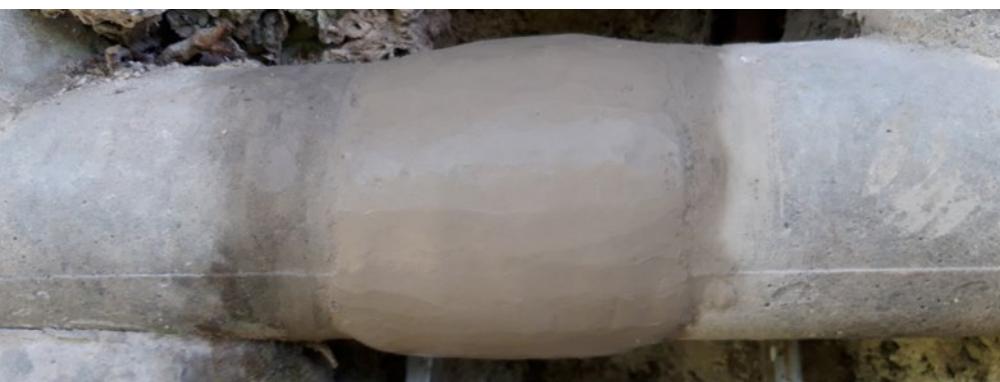
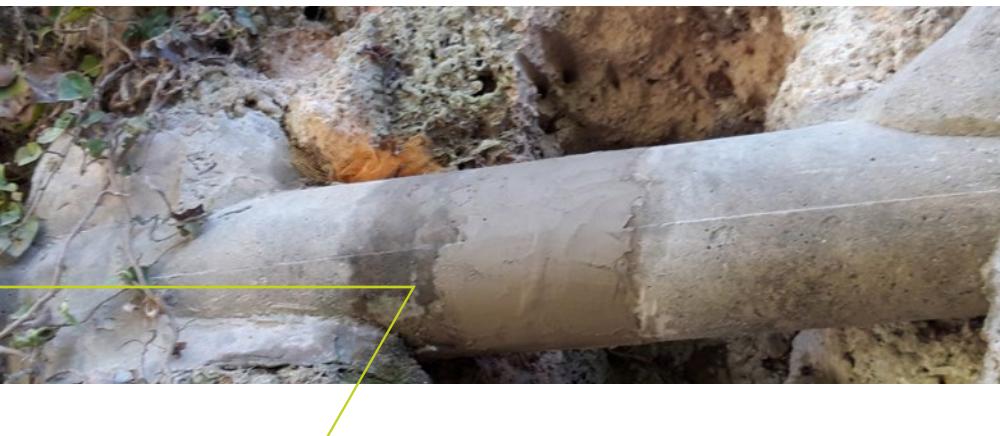
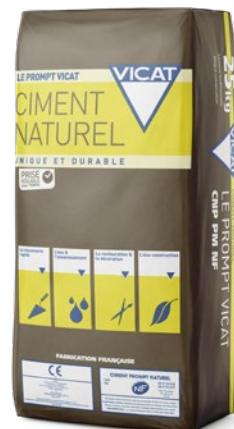
estate. Cracks and old repairs had to be treated to restore functionality.

- Remove friable parts
- Open cracks with a concrete saw
- Clean and dust the area
- Moisten before applying mortar

- Mix Prompt Natural Cement with water to obtain a thick paste
- Seal cracks

- Mix: 1 part sand (0/4) + 1 part CNP
- Apply mortar firmly to ensure adhesion
