PROJECT SHEET
Stone Wall Repair

ISÈRE, FRANCE

THE PROJECT

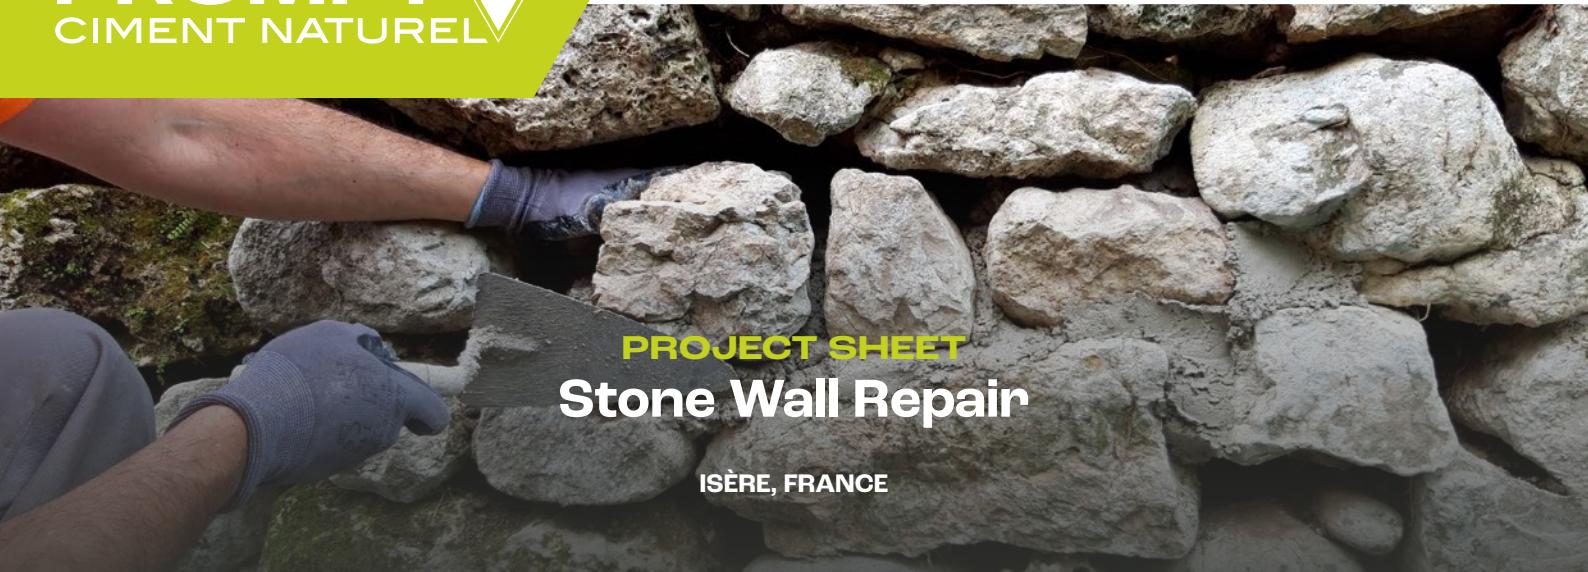
This 18th-century enclosure wall had deteriorated over the years due to weather and invasive vegetation. Roots growing in the joints gradually loosened the

stones bonded with earth. Before a complete repointing, the masonry had to be reinforced by resetting stones and injecting grout to fill inaccessible voids.

- Remove vegetation
- Remove loose stones
- Chisel out joints and friable parts
- Clean, dust, and moisten repair areas

- Binder: 200–450 kg/m³ (15% CNP)
- Mix: 90–150 L sand + 35 kg NHL 3.5 lime + 5 kg CNP
- Add TEMPO retarder to mixing water

- Lay stones and fill joints
- Inject grout where mortar cannot penetrate
- Scrape and brush mortar during setting to prepare for finishing joints
